## Strengthening Technique of Reinforce Concrete Structure: Bangladesh Perspective

**Abstract.** *Problem Statement:* Strengthening of existing building is significant issue when need to carry additional load. Section Enlargement, RC jacketing and retrofitting by FRP are common strengthening methods used by practical engineers in Bangladesh to increase the load carrying capacity of an existing building. The aim of the study was to determine the most effective and economical strengthening methods among the mentioned methods in perspective of Bangladesh for one storey vertical extension. *Approach:* Methodology of the study included, making plan and beam-column layout, capacity assessment, determination of allowable bearing capacity of soil, structural analysis and cost analysis. The actual compressive strength of concrete was determined by core test. *Results:* After the analyses, results show that the column and foundation merely carry the load from super structure. But, the column and foundation is not capable of carrying extra load from additional storey as the design vertical load for four storeys will exceeds the load carrying capacity of the element and hence, strengthening i

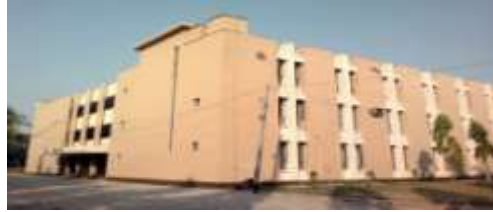
Fig. 1. Existing building.

The case study building is shown in figure 1 which was designed according to the code of Pakistan. The plan area of the existing building is 204 ft. by 113 ft. Size of reinforced concrete column and foundation (columnar) is 10 in. by 14 in. and 8 ft. by 8 ft. The building is in the earthquake zone 3 according to BNBC.

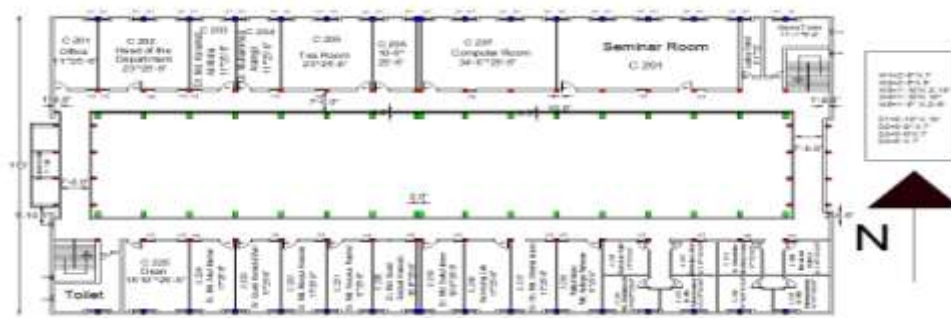
Fig. 3. First floor plan

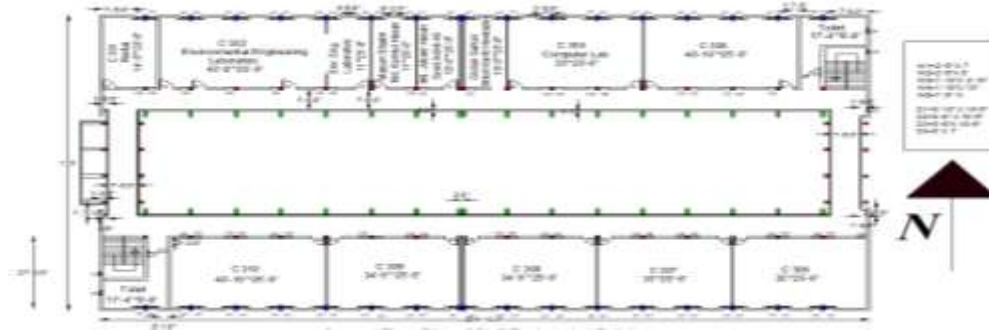
Fig. 4. Second floor plan
